Fixing a seized ABS pump on a Porsche 968, 944S2, 996

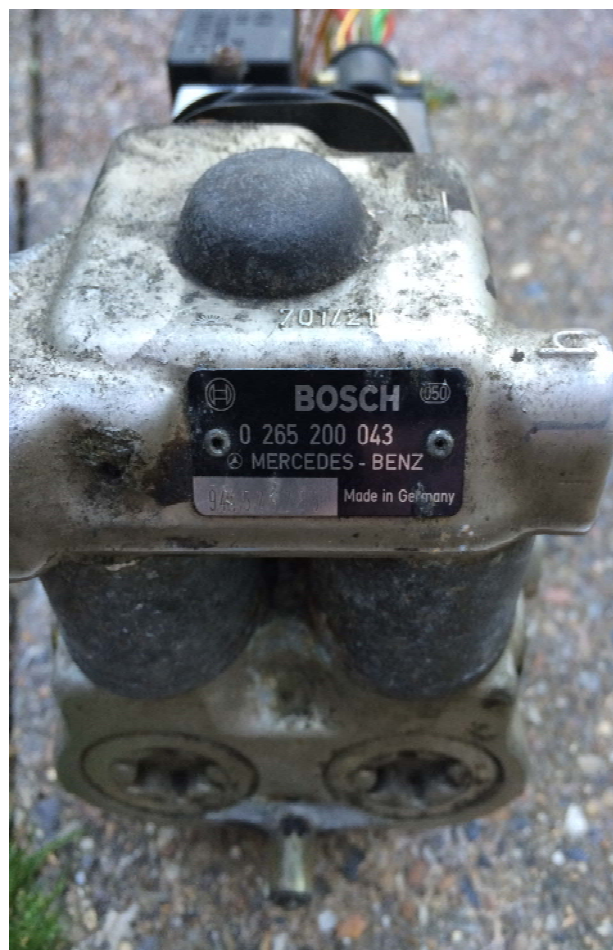
This is the donor pump out of a 500sec 1995 from eBay £10.00 plus shipping.

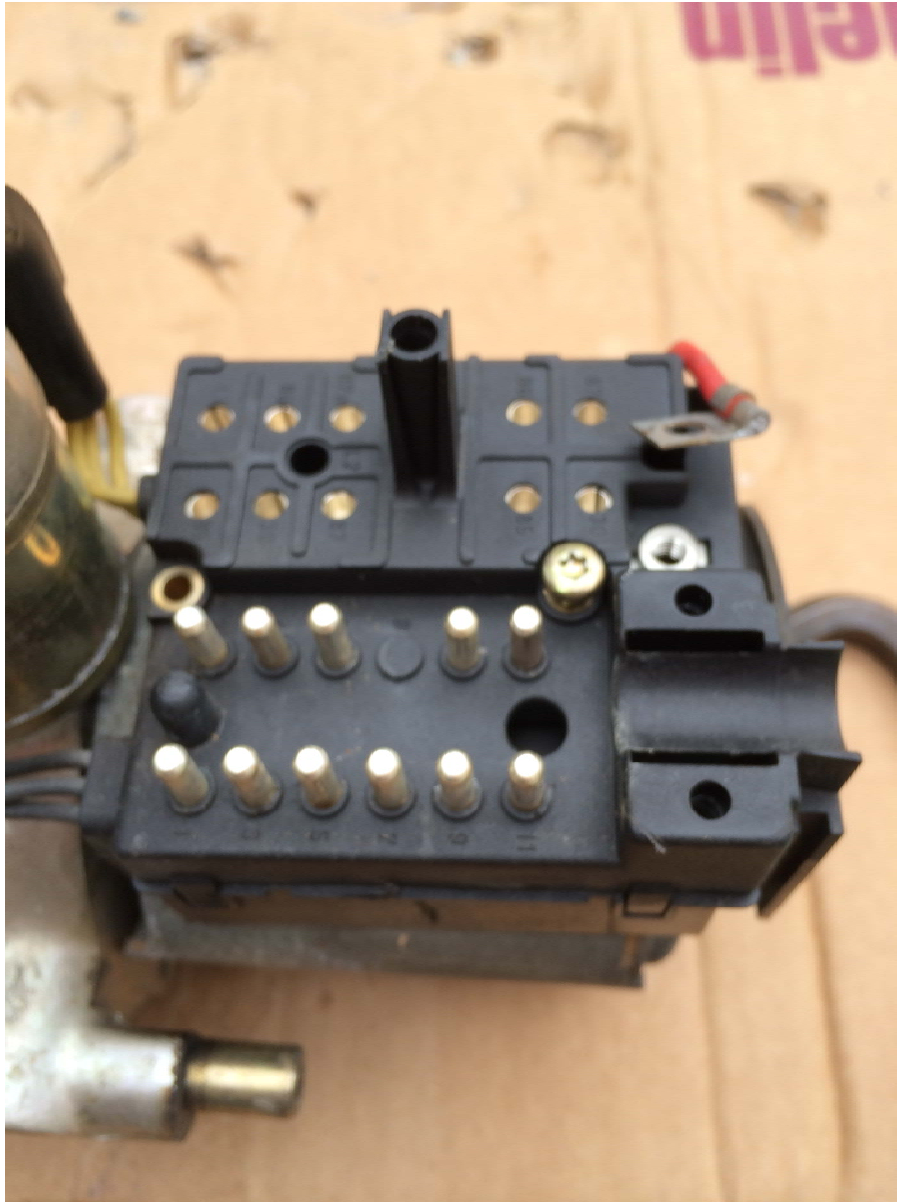
One removed in this picture and the red wire also disconnected.

1. Remove the top cover and the relays, the cable connection if connected
2. Then remove the two Torx screws the hold the relay switching block in place

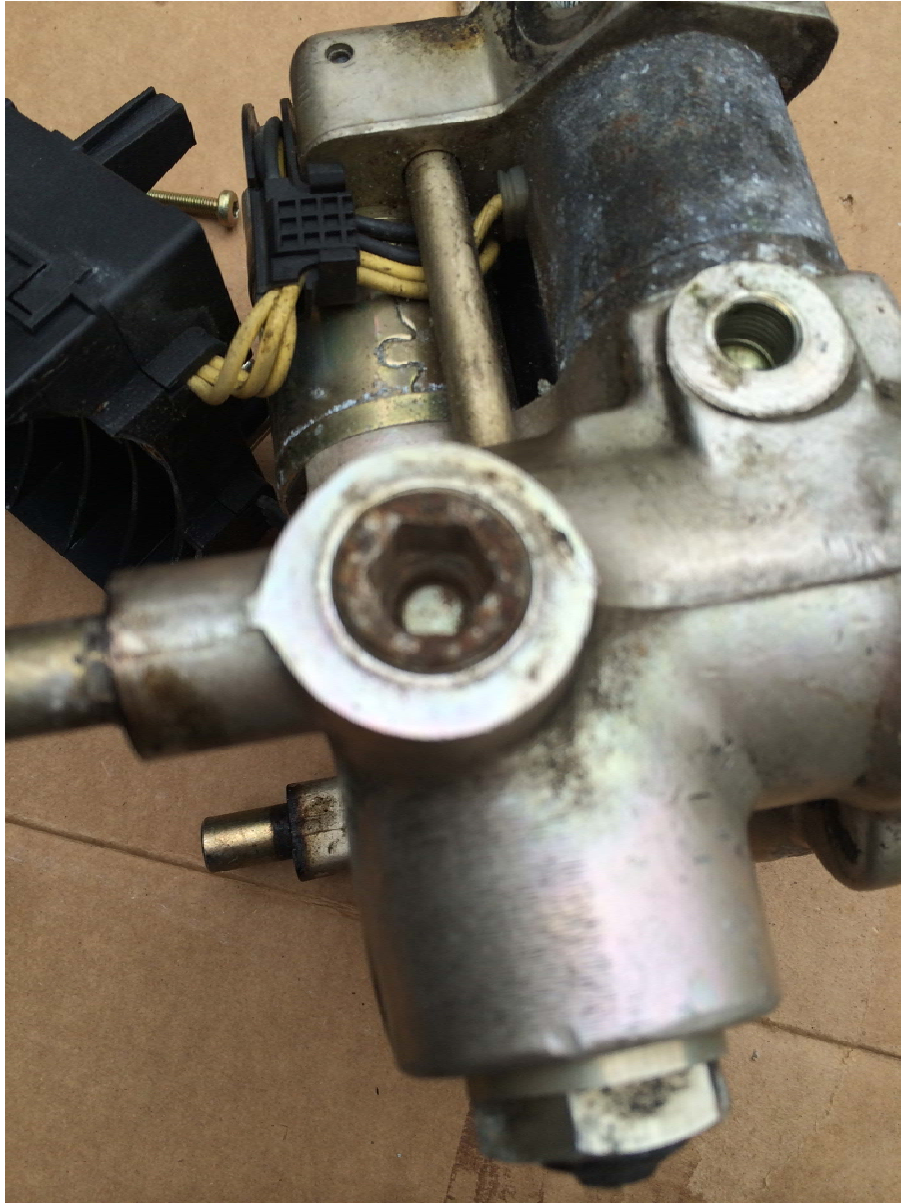
These will require some BFI to get out.

5. The next task is to remove the two 10mm Allen nuts from the ends of the pistons.

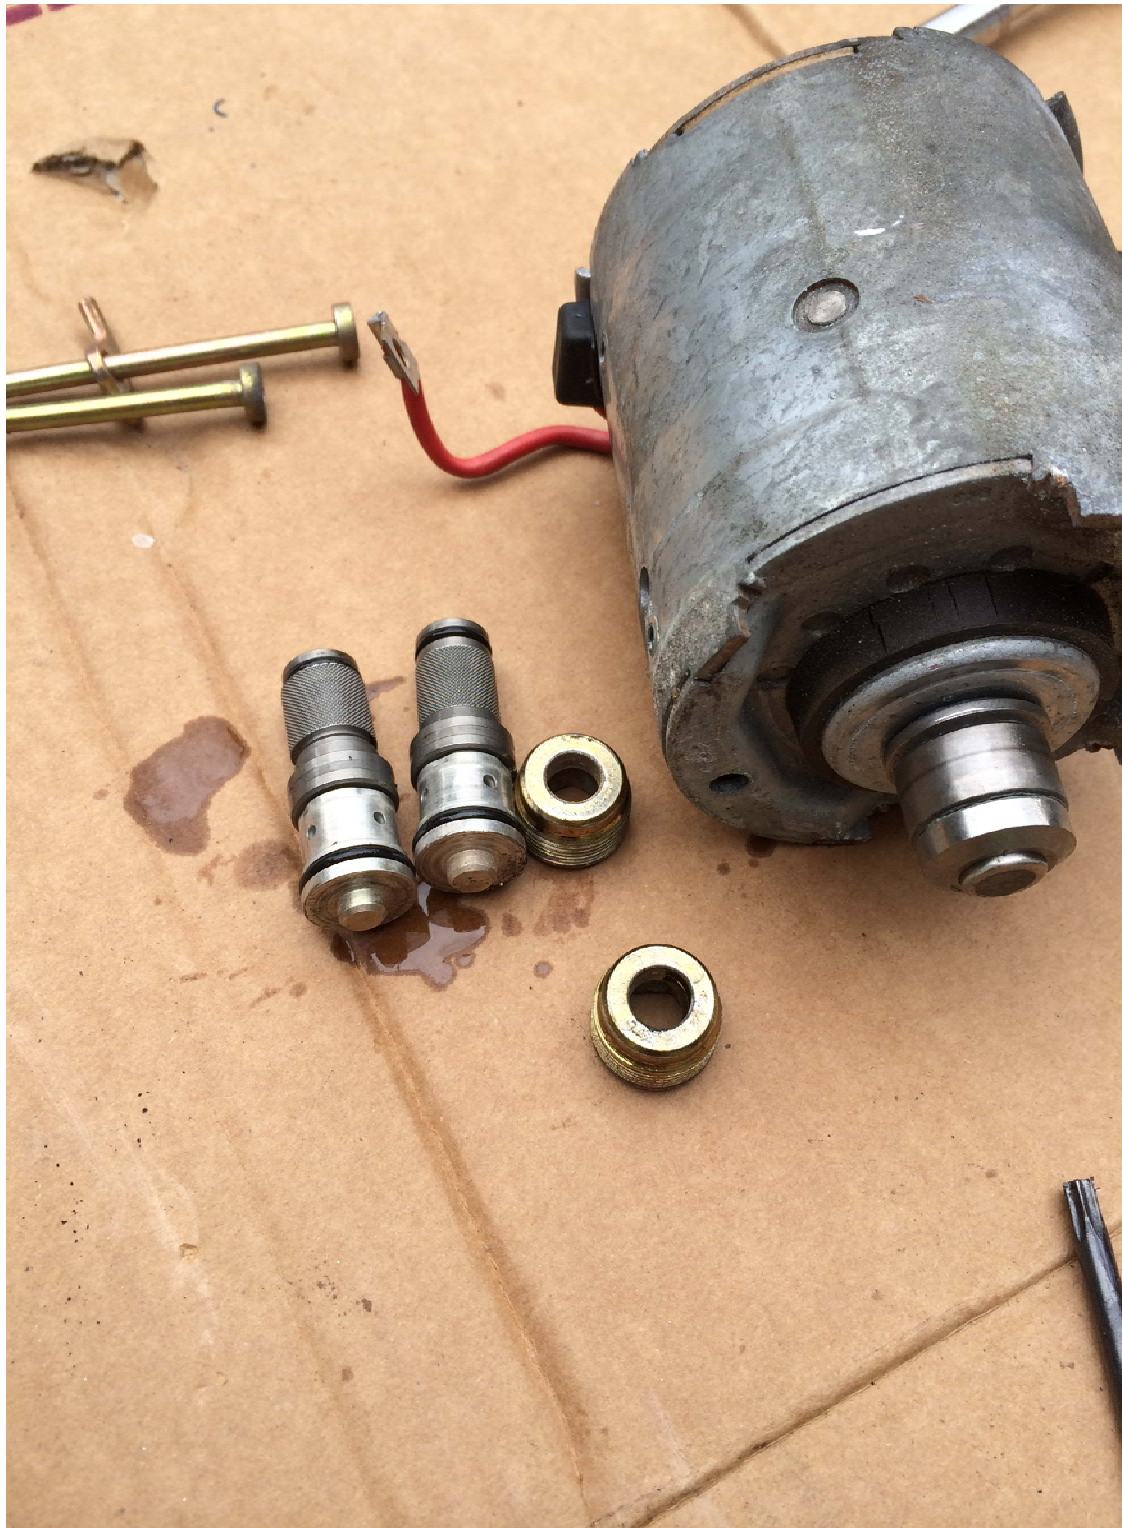
These are all the parts needed to fix the 968 pump.

Put these in the 968 pump same method, put the repaired pump back in the car and then bleed the brakes furthest point first NS rear caliper.
